Redfish Inspections

Property Inspection Report

123 Easy Street, Houston, TX 77035
Inspection prepared for: Home Owner
Real Estate Agent: -

Date of Inspection: 10/14/2016 Time: 8:30 AM; 10:30 AM
Age of Home: 58 years old Size: 1853 sqf
Weather: Overcast

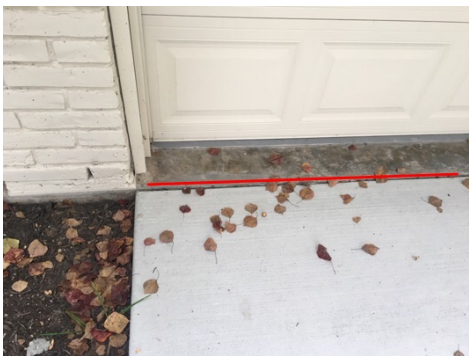
The structure had attaching slabs "expansion joints" between the driveway and the garage/house. This is a location for wood destroying insects (termites) to enter the home. Home owner needs to perform frequent inspections of these areas.

Driveway/walk to foundation:
Monitor area for insect activity

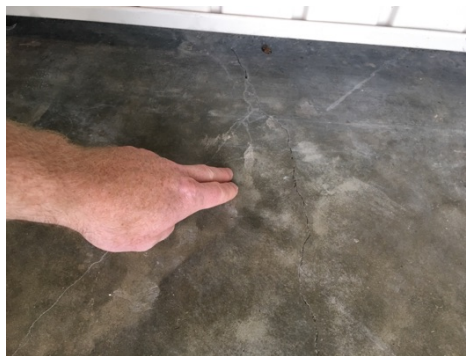
Hairline cracks were observed in the foundation slab of the house. These are not uncommon, where under 1/4 inch wide and should be monitored. This was noted in the entry, garage, and left.

Entry: hairline crack

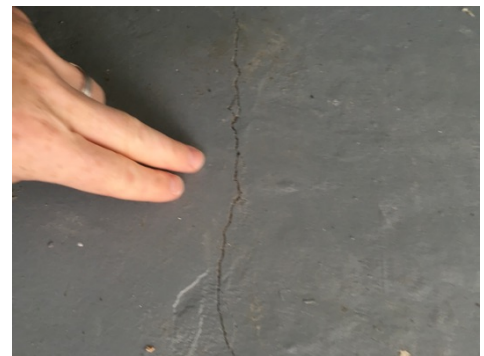
Garage: Hairline crack

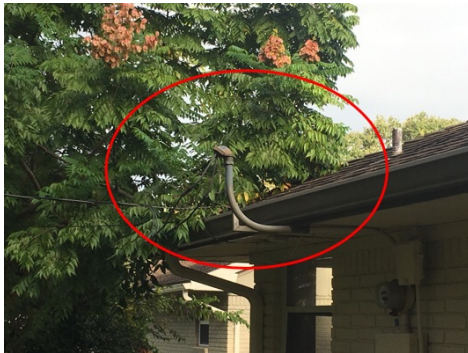
Foliage was noted close to the structure, we recommend trimming all bushes away from structure. Bushes and trees too close to the structure can prevent the wall from drying properly, their roots can affect the foundation and their branches can damage the structure. This was located on the rear, and right.

Rear: Foliage close to structure

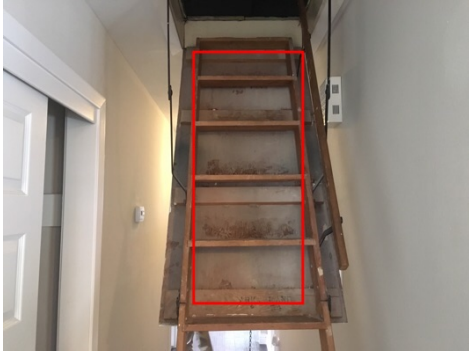
The pull-down stair/scuttle panel to the attic was not insulated. We recommend adding insulation for improved energy efficiency.

Pull-down stairs/scuttle panel lacked insulation

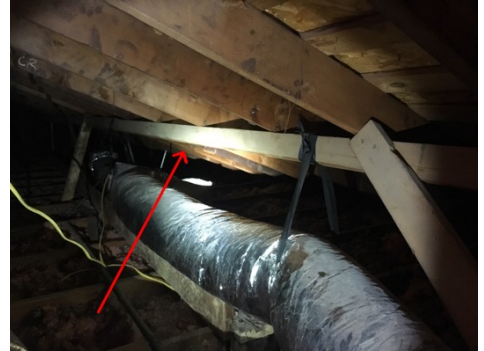
Today's standards require having the purlins the same size as the roof rafters and must be supported every 4 feet. No deflection was noted within the attic space or on the exterior.

Undersized purlins - insufficiently supported

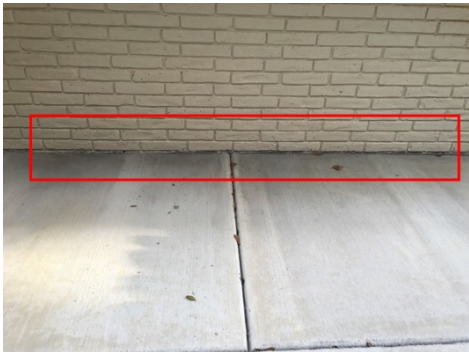
Blocked weep holes were noted at the brick veneer walls. These should be cleared to allow any possible moisture from running out. These were located on the rear.

Rear: blocked weep holes

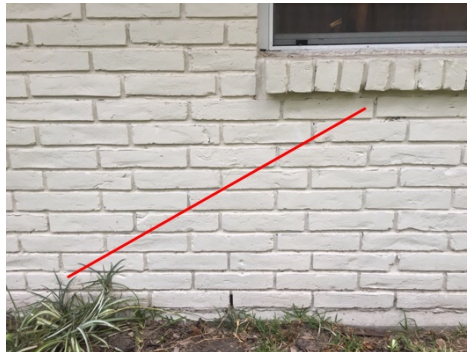
A step crack was observed on the exterior brick veneer. This typically is an indication of structural movement. We recommend patching and monitoring. This was noted on the rear, front, and left.

Rear: step crack

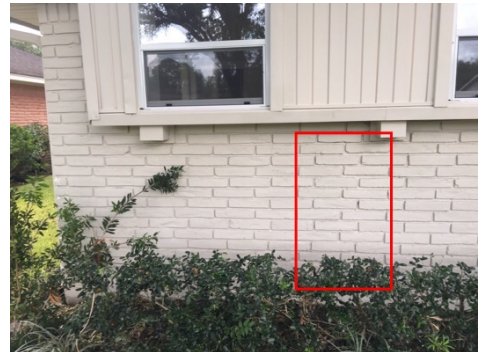
Front: Step crack

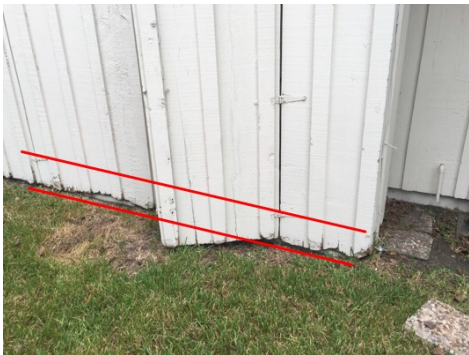
Wood decay was observed on the exterior siding. We recommend repairs/replacement to all decayed wood to prevent further deterioration and creating conducive conditions for wood destroying insect activity. This was noted on the right.

Right: wood decay

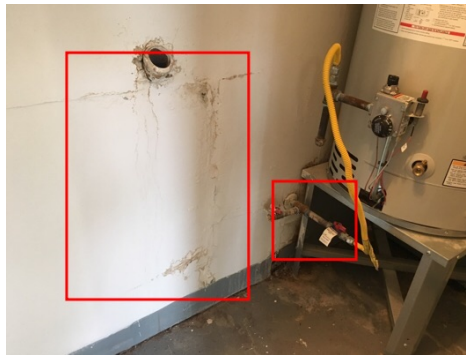
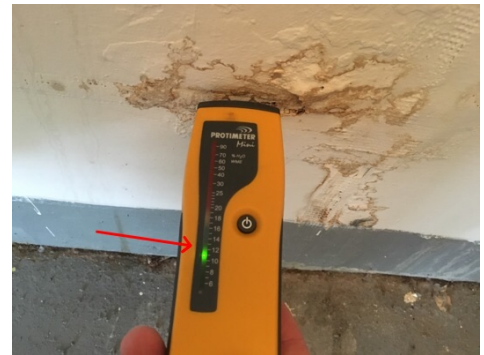
Moisture staining and damage was noted and the area was confirmed with a moisture meter and infrared thermal Imager to be dry at the time of inspection. We recommend monitoring. This was observed in the garage laundry room.

Garage laundry room: Moisture stain and damage dry at time of inspection

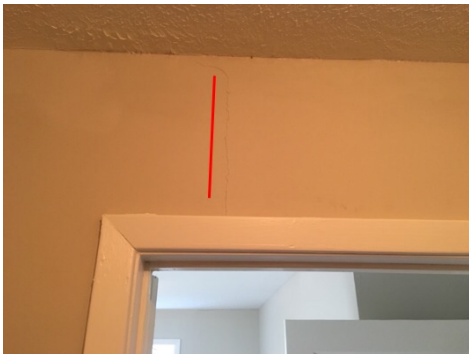
Hairline/shrinkage cracks were noted in the interior walls. This condition was mainly cosmetic in nature and should be patched. This was noted in the bedroom 2 closet, bedroom 3 closet, bathroom 2, and living room.

Bedroom 1: Hairline crack

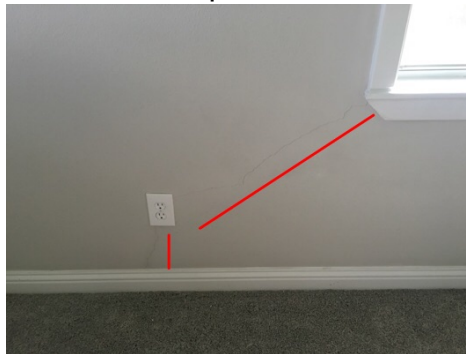
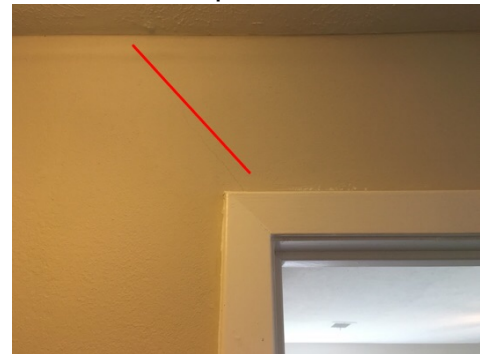
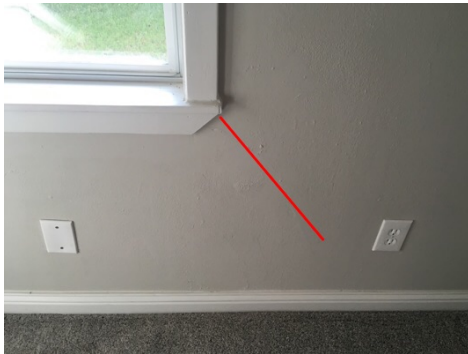
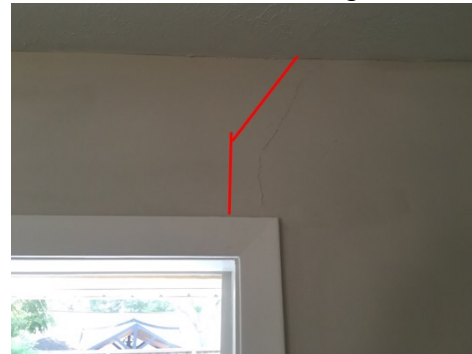
A diagonal crack was observed on an interior wall. This typically indicates foundation movement. We recommend repairing and monitoring. This was observed in the hall, bedroom 1, and 3.

Bedroom 1: diagonal crack

Hall: Diagonal crack

Bedroom 3: Diagonal crack

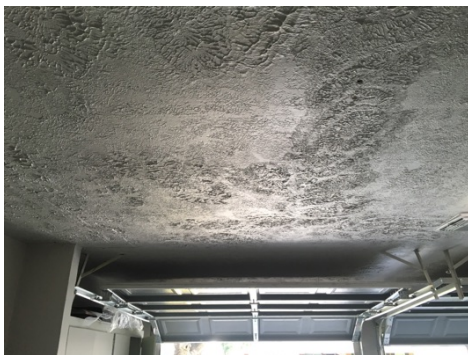
Evidence of patching was detected which indicates previous work performed. We recommend monitoring. This was observed throughout the house.

Garage: patchwork

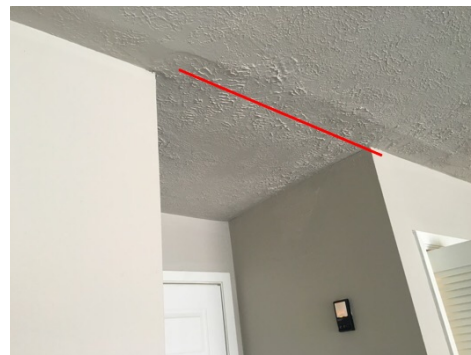
Hairline cracks which were by nature mainly cosmetic were noted on the ceiling. We recommend having these caulked and painted. This was observed in the garage.

Garage: Hairline crack

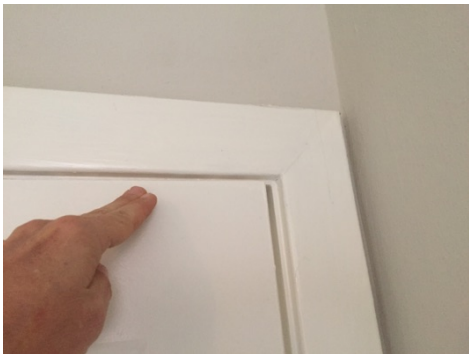
A door was noted out of square, which indicates movement within the structure, but still operate as intended. It is impossible to determine the rate of the movement in a one time inspection. We recommend monitoring the door and adjusting if needed. This was observed in bedroom 3.

Bedroom 3: door rubbed on frame and out of square

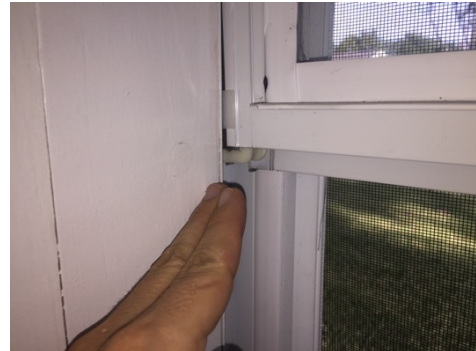
Bedroom 1: loose hardware at left front window

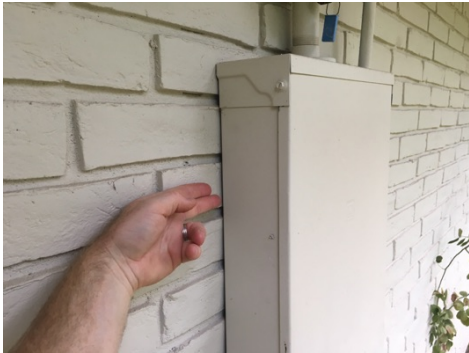
Top and side: Caulk missing at wall connection

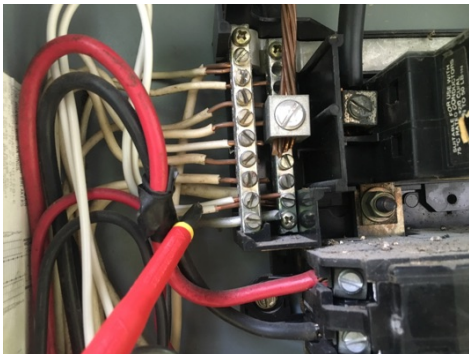
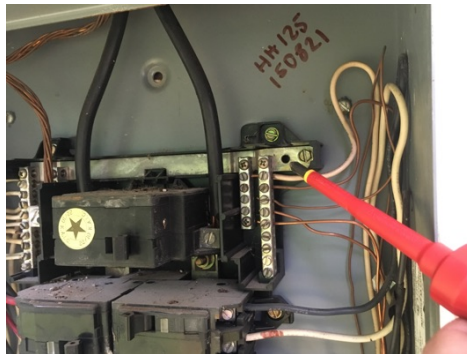
Bonding screw missing

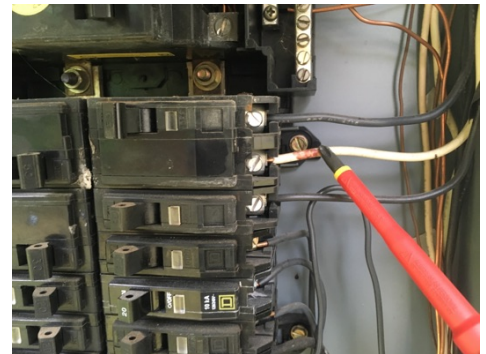
Conductor undersized for breaker

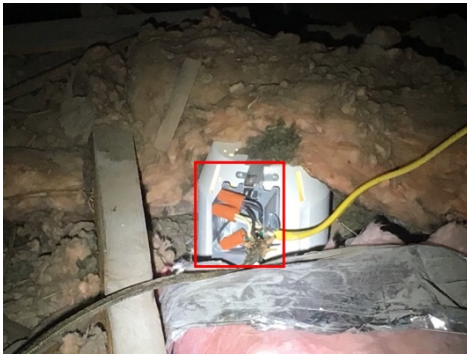
Attic: open junction box

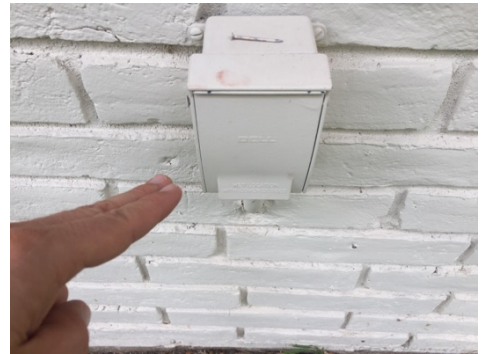
Exterior outlets: Bubble cover recommended

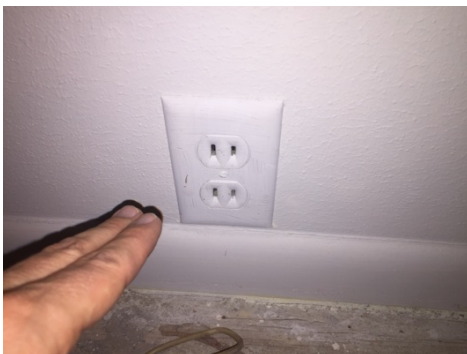
Attic: painted outlet

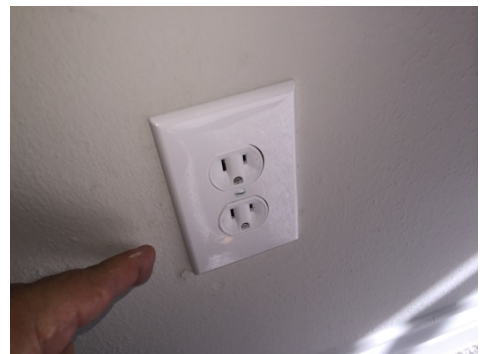
Bedroom 2: Loose outlet

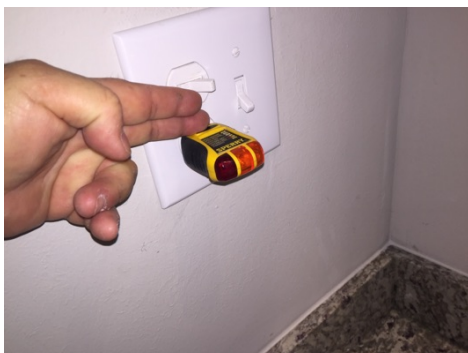
Bathroom 1: Outlet not GFCI protected to the left of the lavatory

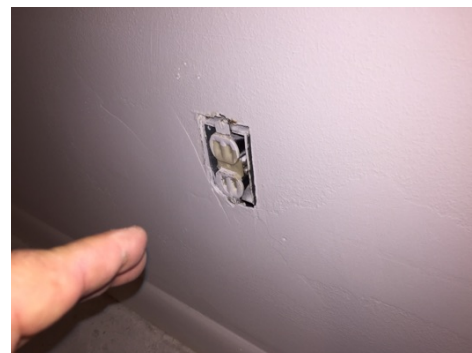
At the time of the inspection, an electrical outlet/switch cover plate was not installed. This condition left energized electrical components exposed to touch, a shock/electrocution hazard. We recommend a cover plate be installed. This was observed in the attic.

Attic: Outlet missing cover plate

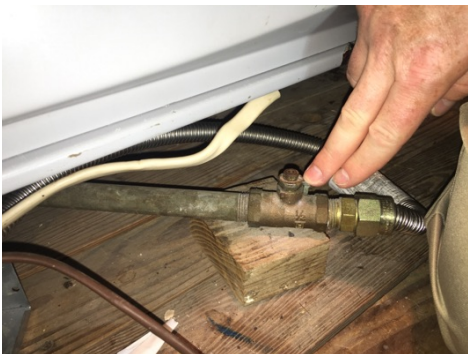
The gas shutoff valve was damaged. We recommend repair.

Shutoff valve damaged
 REI 7-5 (05/4/2015)

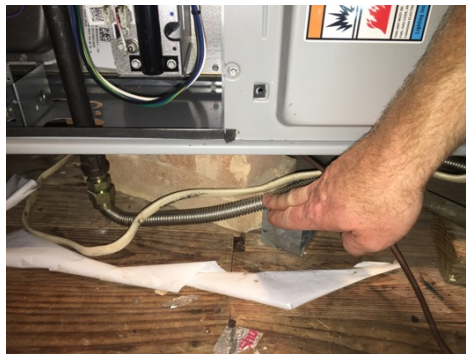
The gas supply pipe contained no drip leg. A drip leg is generally recommended but not always required, depending on the local Authority Having Jurisdiction (AHJ). The purpose of a drip leg is to prevent particulates or moisture from condensation from entering and clogging the furnace gas valve, which can cause the furnace to shut down. You may wish to consult with a local licensed, professional, competent and qualified HVAC technician concerning the advisability of installing a drip leg in the gas line.

Missing drip leg

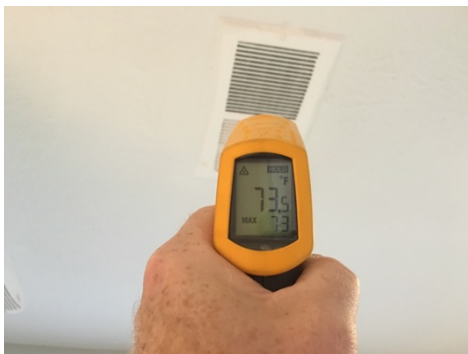
A significant temperature increase was measured at a register compared to the rest of the house. Should this affect your living comfort, we recommend having the duct further evaluated and adjusted as needed. This was noted in bathroom 1.

Temperature measured in bathroom 1

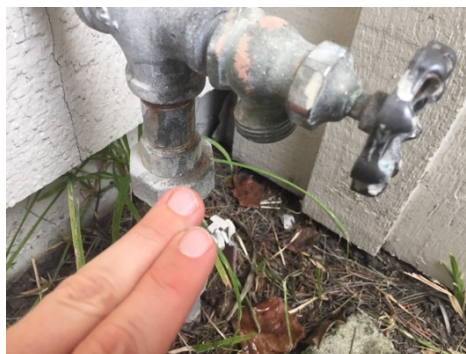
Around house: Back flow preventer recommended

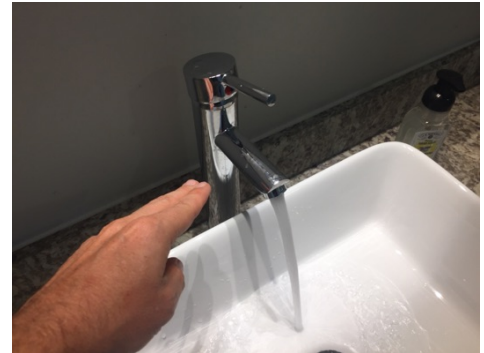
Bathroom 1: loose faucet

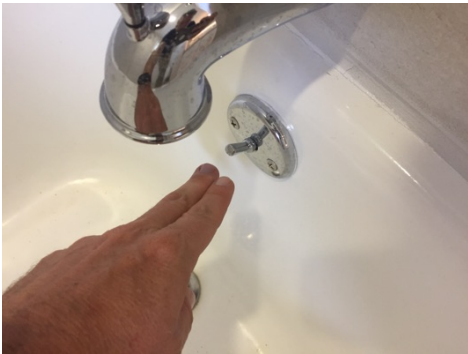
Bathroom 1: drain stop at tub would not retain water

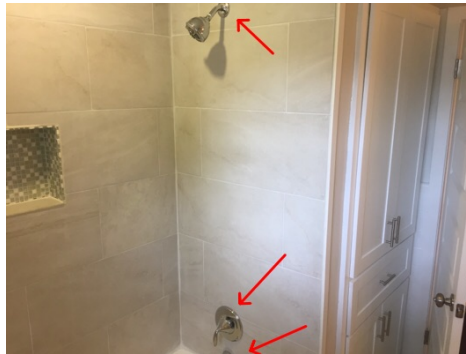
Bathroom 1: missing caulk at wall protrusions

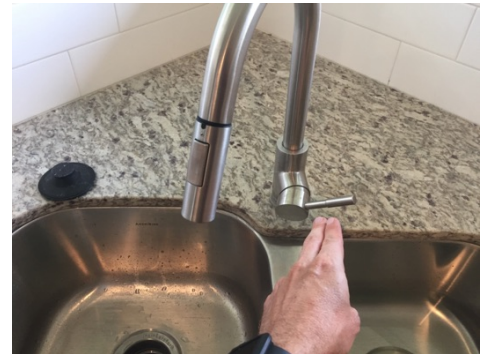
There was no cold water at the kitchen faucet at the time of inspection. We recommend having this further investigated to determine the cause and have any necessary repairs made.

Kitchen: no cold water at faucet

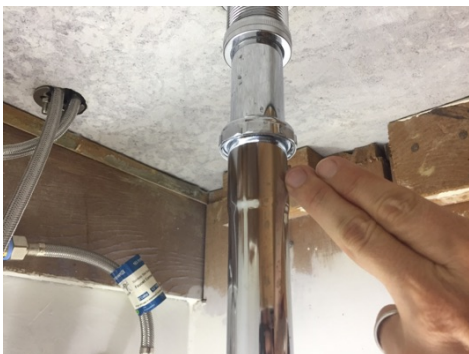
Bathroom 1: leak at drain stem

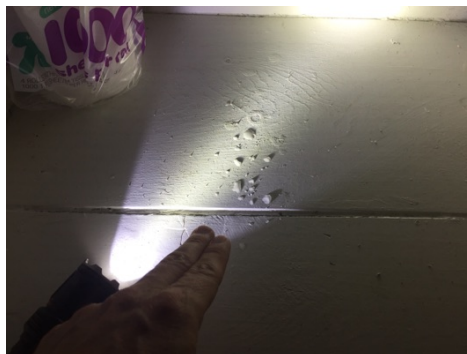
Bathroom 1: water on cabinet floor from leak at drain

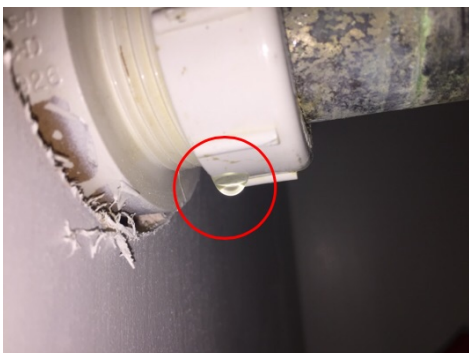
Bathroom 2: leak at drain

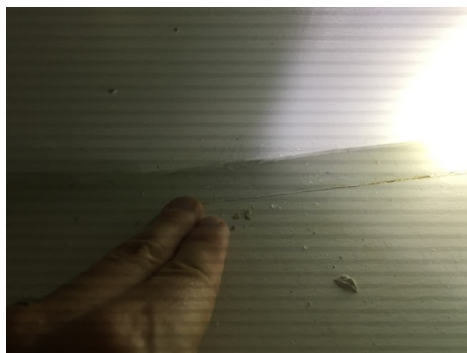
Bathroom 2: water on cabinet floor from leak at drain

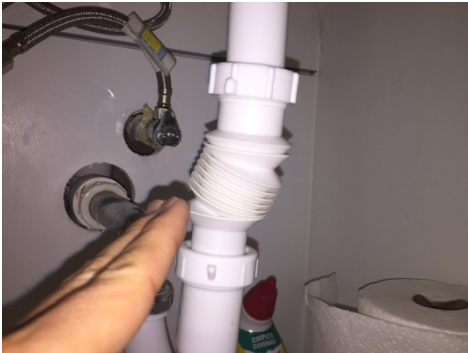
Bathroom 2: corrugated drain line

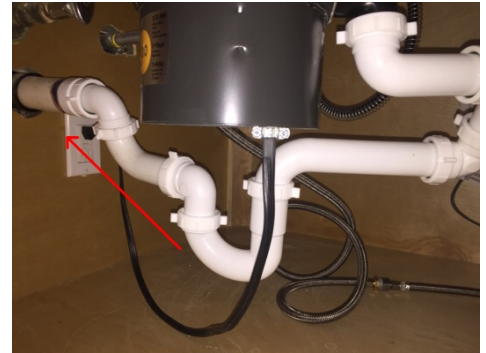
A drain line was improperly sloped at bathroom/kitchen sink. We recommend having this improved to ensure all water drains as it should. This was found in the kitchen.

Kitchen: improperly sloped drain line

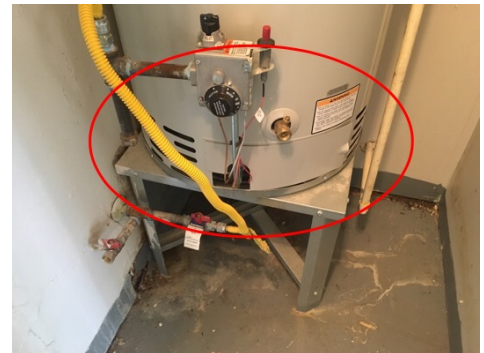
Missing safety pan

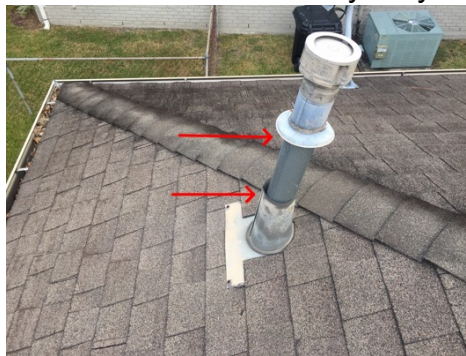
Storm collar too high

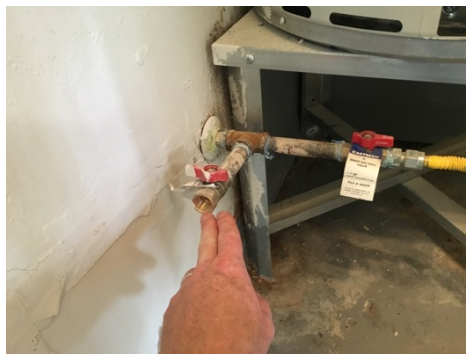
An uncapped gas line was observed at the time of inspection. We recommend having this capped when not in use to prevent accidental valve opening. This was observed in the garage laundry room.

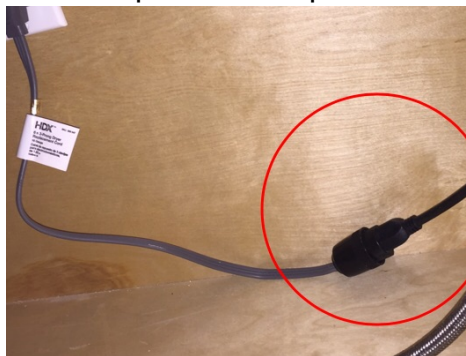
The electrical connection to the dishwasher was improper at the time of the inspection. The dishwasher should either be powered by an approved appliance cord plugged into a dedicated outlet or be wired directly to a main electrical or sub-panel, with properly spliced connections housed within a junction box with a cover installed. We recommend correction be made by a qualified contractor.

Improper electrical connection

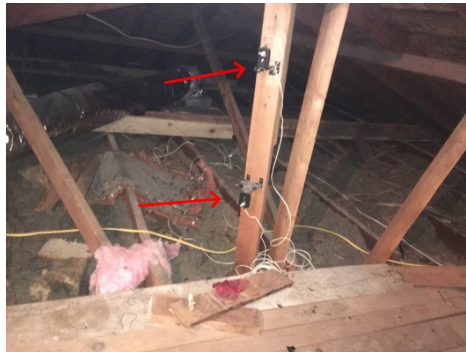
The photo sensor to the right garage door was installed at a height greater than 6 inches. (they were in the attic). Safety standards designed to protect small children limit the maximum mounting height for garage door photo sensors at 6 inches. We recommend correction by a qualified contractor.

Photo eye sensor in the attic were more than 6" off ground
