Redfish Inspections

Property Inspection Report

123 Easy Street, Houston, TX 77035
Inspection prepared for: Home Owner
Real Estate Agent: -

Date of Inspection: 10/14/2016 Time: 8:30 AM; 10:30 AM
Age of Home: 58 years old Size: 1853 sqf
Weather: Overcast

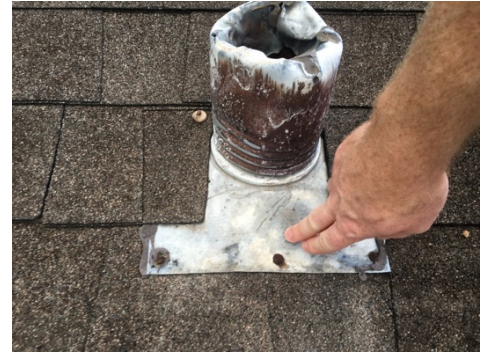
Exposed nail heads

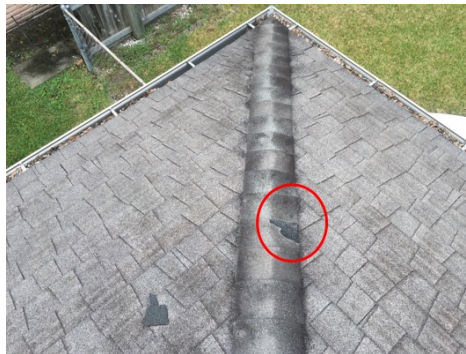
Rear left: torn shingle

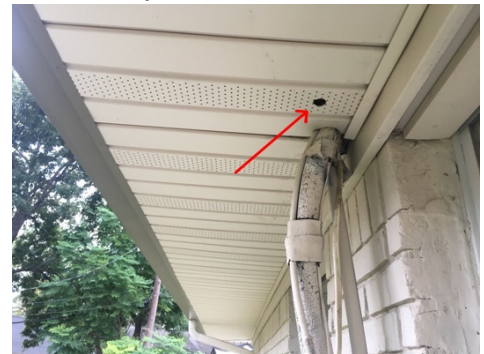
Left: hole in soffit

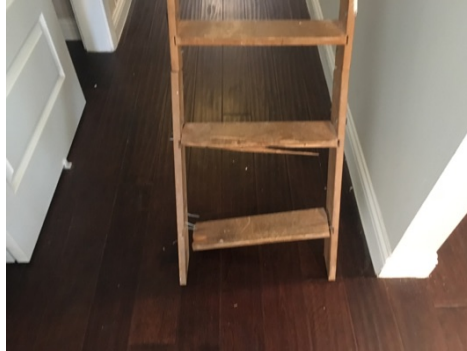
Pulldown stairs: Cracked steps

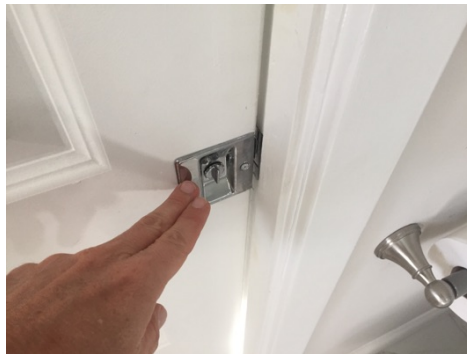
Bathroom 2: would not latch

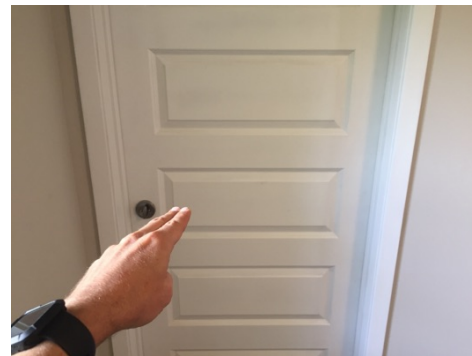
Garage man door: not fire rated

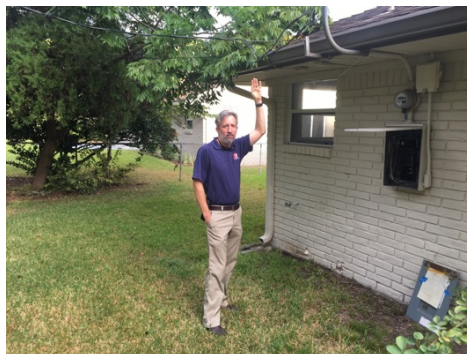
Service too low

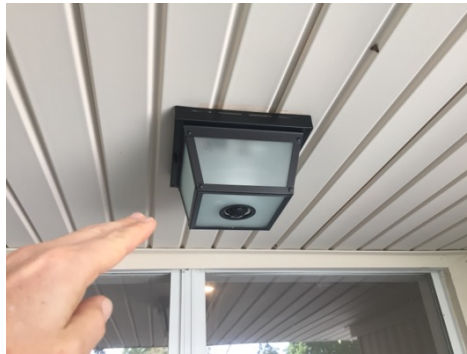
Front porch: inoperable light fixture

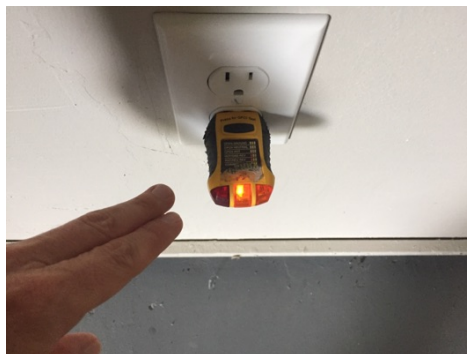
Garage: open ground at multiple outlets

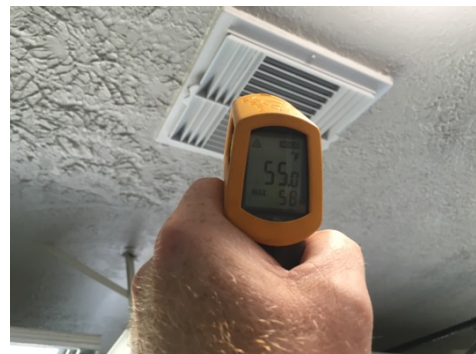
An active air vent/duct was observed in the garage. Today's standards do not allow for vents/returns in a garage to be connected to the rest house conditioned air as fumes could escape/be recirculated into the house. We recommend repair.

Garage: active vent

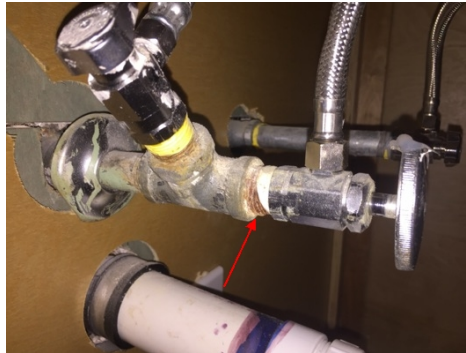
Plumbing distribution pipes in contact with each were made of different types of metal and may cause **galvanic corrosion** which will result in deterioration and eventual leakage. We recommend installation of a dielectric union by a licensed, professional, competent and qualified plumbing contractor.

Kitchen and bathrooms: dissimilar metals in contact

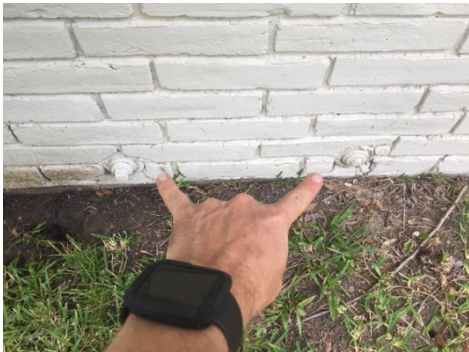
Note: The home was equipped with cast iron drains. Cast iron drains have a typical life expectancy of approximately 50 years when installed under ground and 60-70 years when installed above ground. These drain pipes are not commonly used today because the sewer gases corrode the interior of the pipe which eventually leads to restrictions in the pipe and failure. We recommend consulting with a plumber about getting these replaced with an approved drain material.

Right rear: cast iron drains

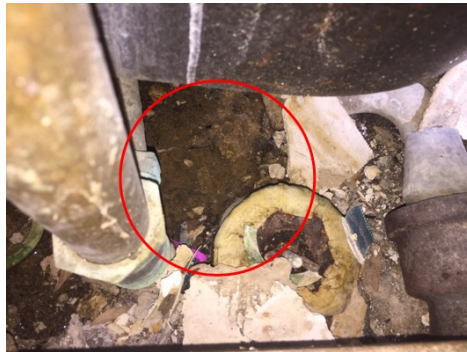
A leak was noted under a tub. Water was observed seeping up from the soil indicating there was a failure of the cast iron drain. We recommend having this repaired. This was observed in bathroom

Bathroom 1: water under tub near drain

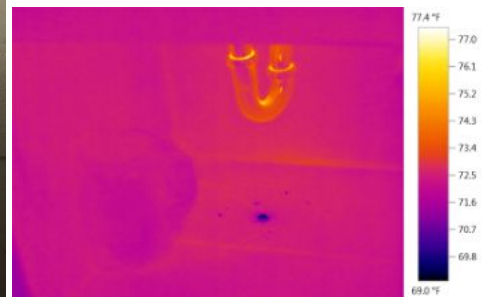
A leak was noted under a lavatory at the drain. We recommend having this repaired. This was observed in bathroom 1 and 2.

Bathroom 1: water on cabinet floor from leak at drain

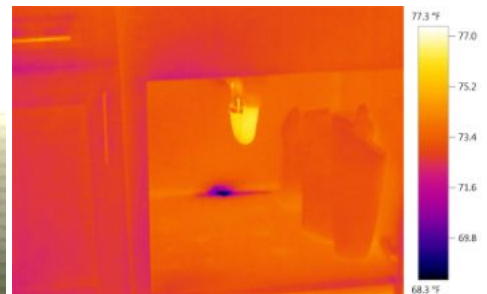
Bathroom 2: water on cabinet floor from leak at drain

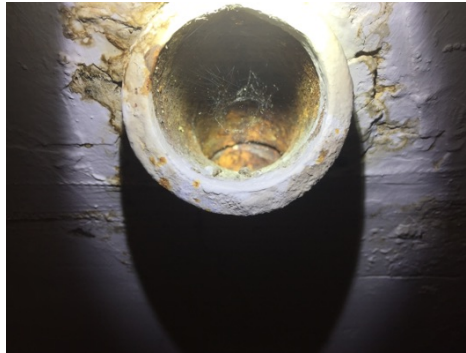
Garage: cast iron drain

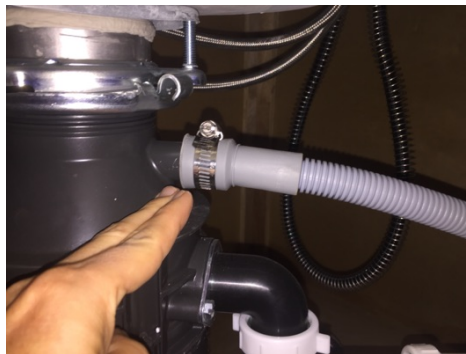
The dishwasher was not operated at the time of inspection. The drain knock out at the garbage disposal had not been removed. We recommend having this operated when the knock out has been removed.

Drain Knock out at garbage disposal still in place
