Redfish Inspections

Property Inspection Report

123 Easy Street, Houston, TX 77035
Inspection prepared for: Home Owner
Real Estate Agent: -

Date of Inspection: 10/14/2016 Time: 8:30 AM; 10:30 AM
Age of Home: 58 years old Size: 1853 sqf
Weather: Overcast

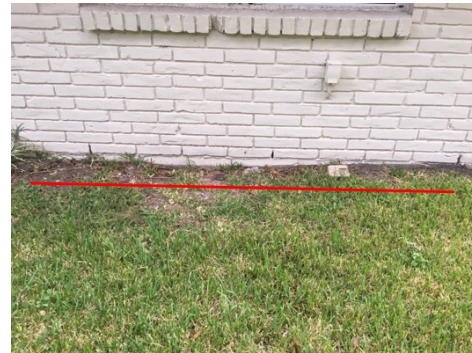
Rear: High soil

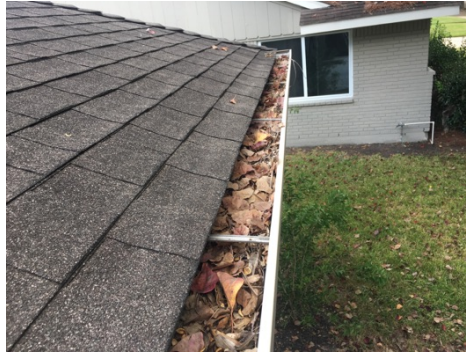
Gutters full

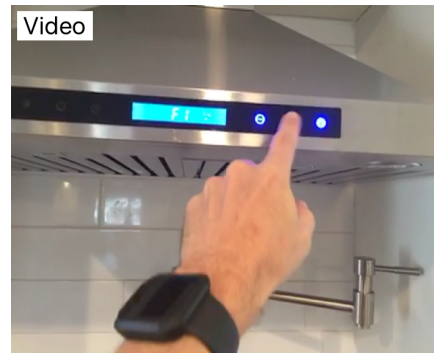
The range hood was excessively noisy at the time of inspection. We recommend having this further investigated to determine the cause and have any necessary repairs made.

CLICK TO PLAY: noisy range hood
